# Portage Creek Sediment Remediation Project Kalamazoo, Michigan

## Pre-Sediment Removal Structure Feature Assessment Removal Areas SA3-A, SA3-B and SA3-Access

F&V Project Number: 809930  
August, 2012

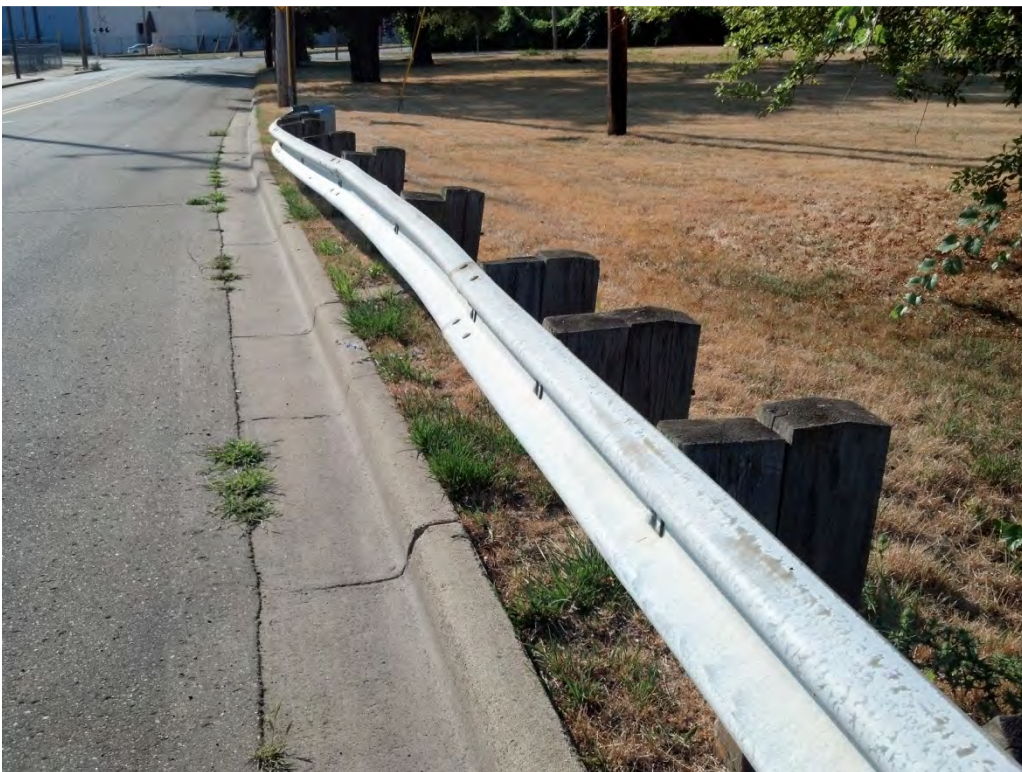
- The southeast concrete curb has severe cracking.
- The southeast guardrail has moderate collision damage and is bowed outward.
- There is a water main suspended along the south fascia.

Bowed guardrail in southeast

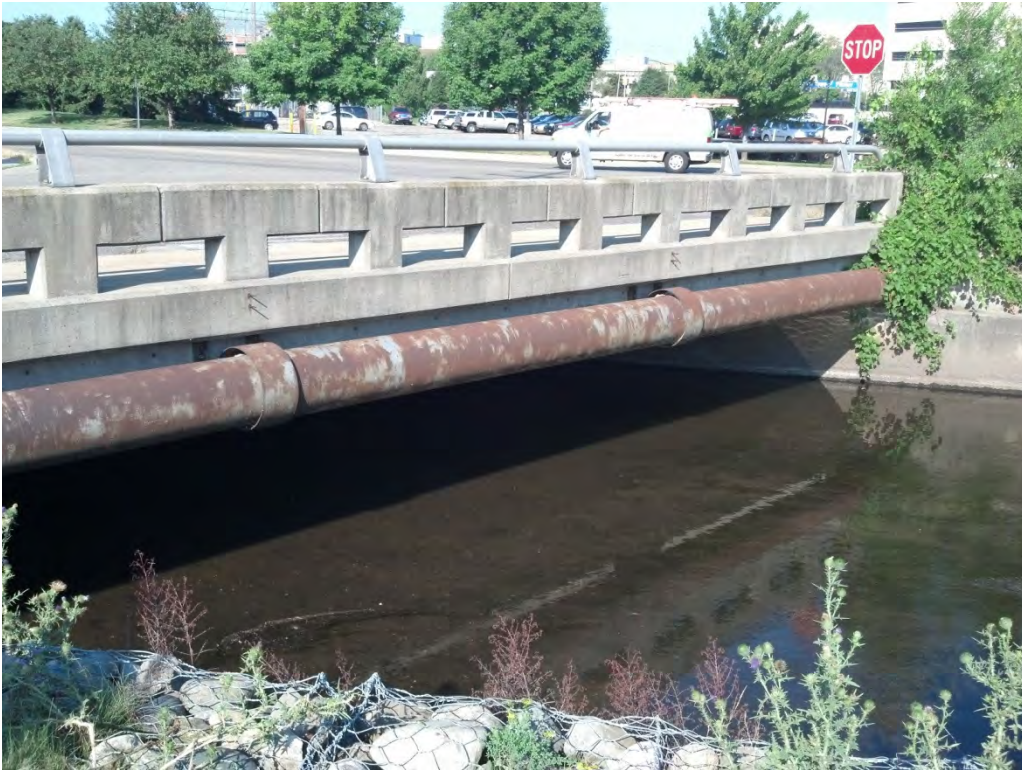
Corrosion on utility supported along north fascia

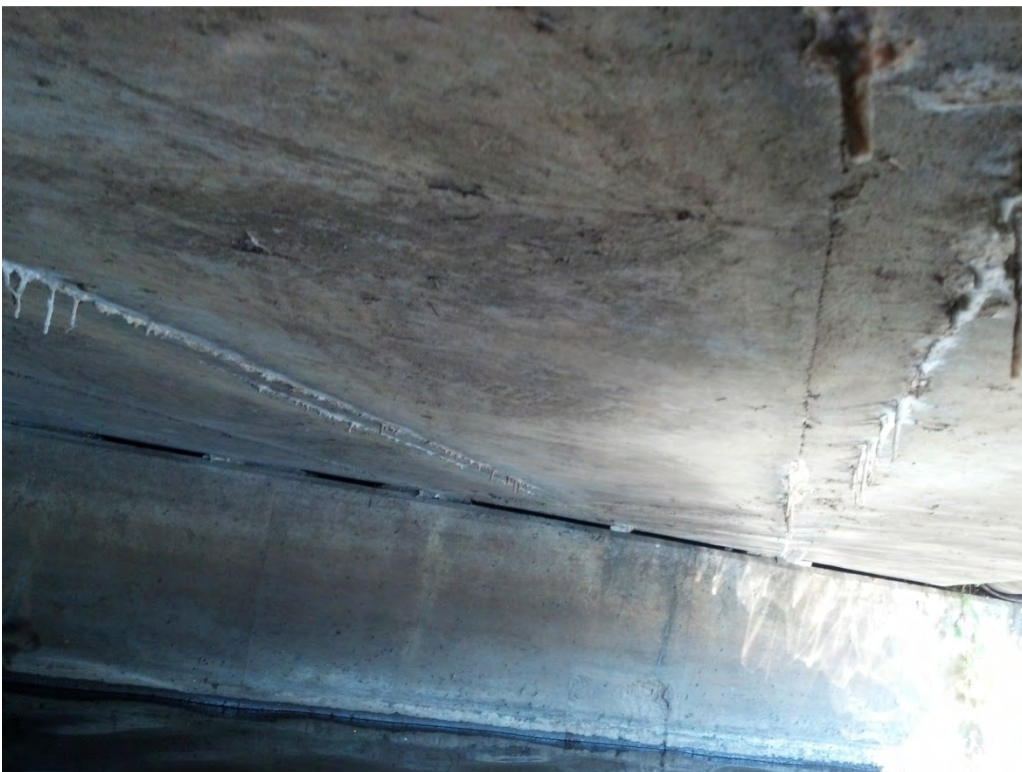
- Gabion baskets in the southeast and southwest are overgrown but in fair condition.
- Overhead utilities were noted north and south of the structure.
- Efflorescence and stalactites were noted along box beam joints.

Efflorescence and stalactites along box beam joints

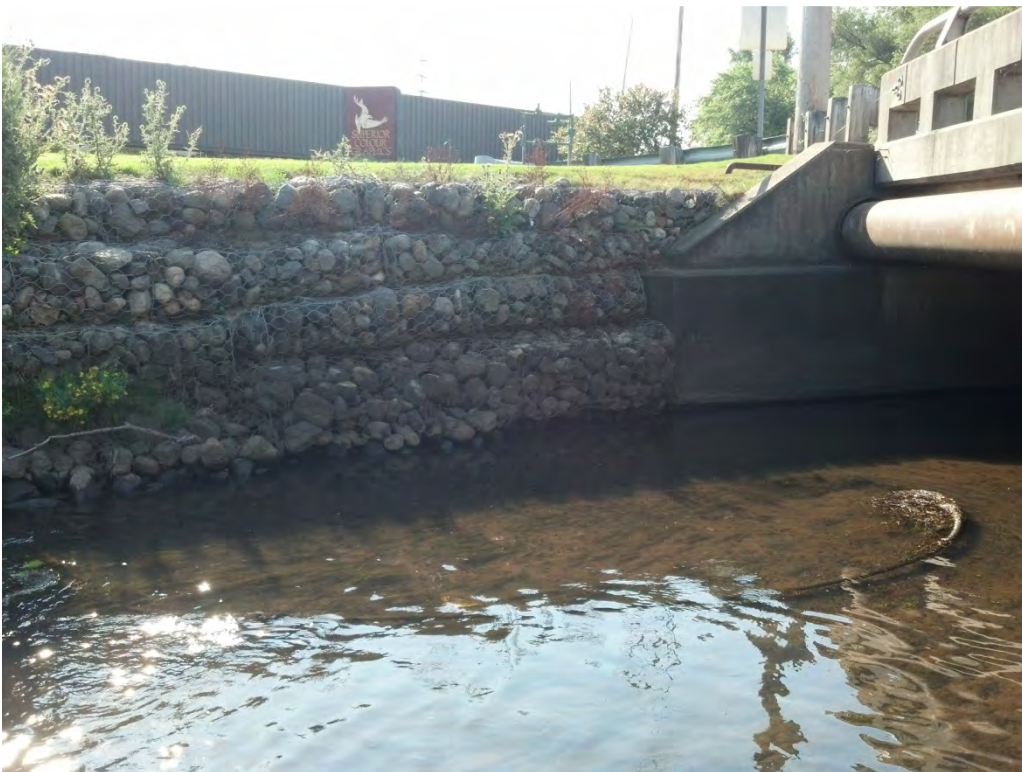
Gabion baskets in northeast with brush growth and displaced stones at waterline

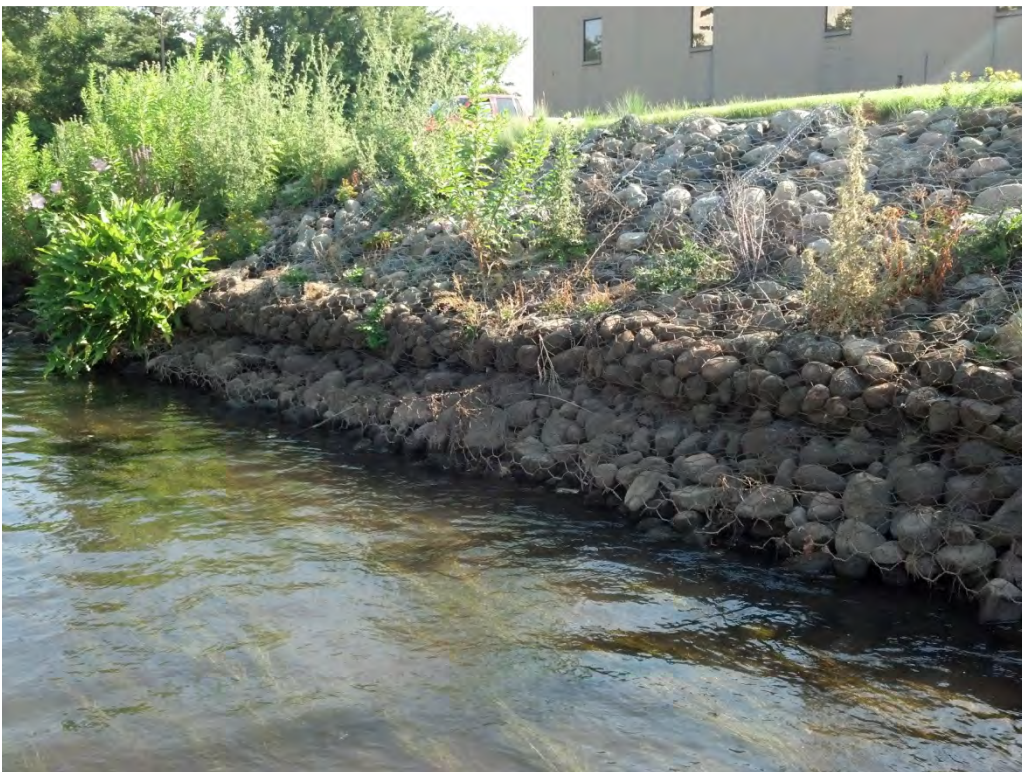
Gabion baskets in northeast with brush growth and displaced stones at waterline

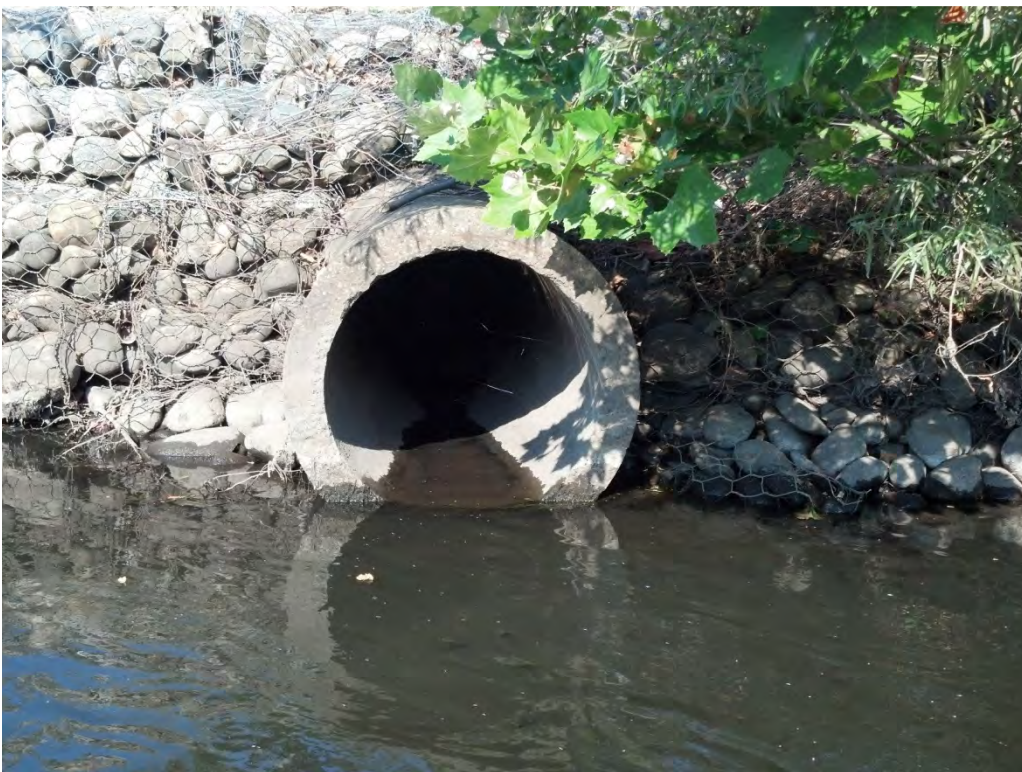
Stone loss in baskets along the waterline

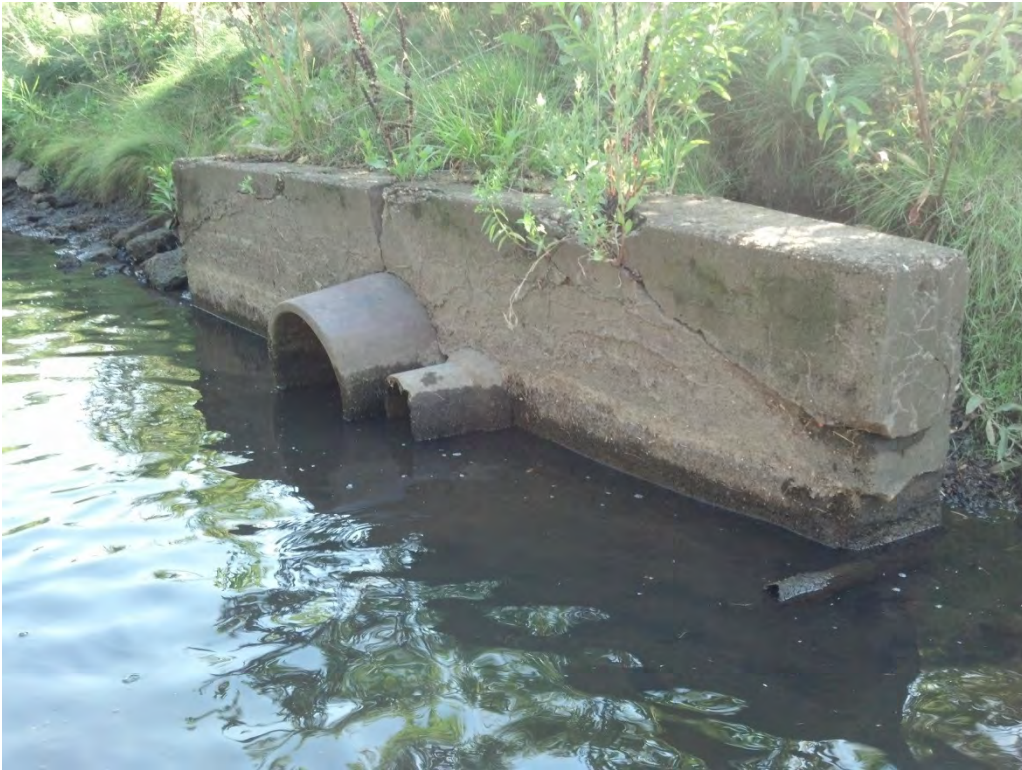
- The bank is severely eroded around the structure, exposing the clay pipes behind the headwall.
- The concrete headwall has moderate to severe cracking.

View of structure from south channel showing cracking and spalling of headwall

- If a cofferdam is required for dewatering, it should be installed with a minimum 4' clearance to the headwall to avoid adversely impacting it. We recommend contacting the property owner for permission to remove the headwall and cut off the outlets at the bank.

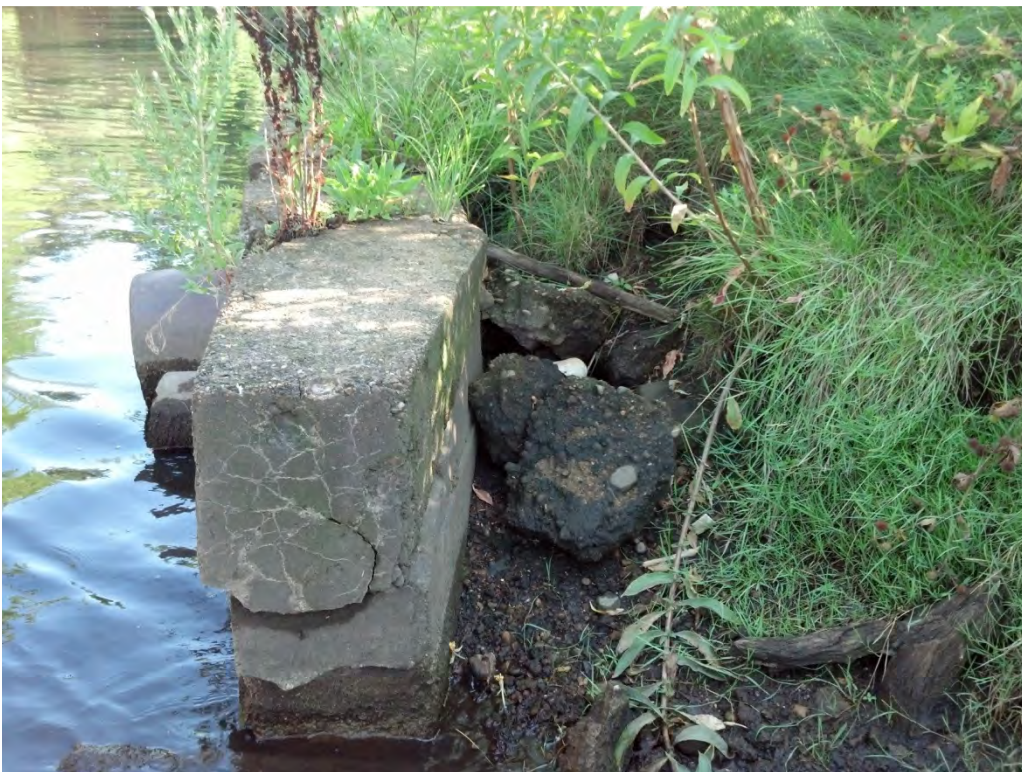
Severe bank erosion behind headwall

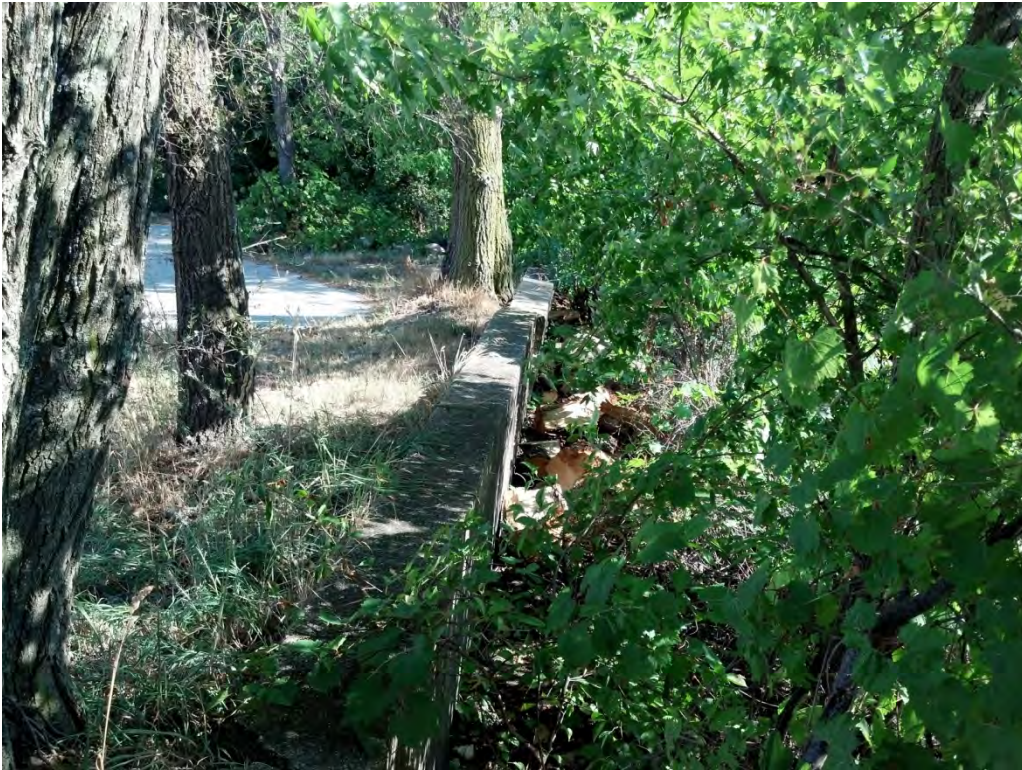
- The concrete retaining wall is in poor condition, leaning in several locations. There are several severe to critical vertical cracks in the wall. Growth of a large tree behind the wall has caused ~2" offset at one of the cracks.
- The parking lot is newer concrete paving.

Critical vertical crack and leaning section of retaining wall at tree growth

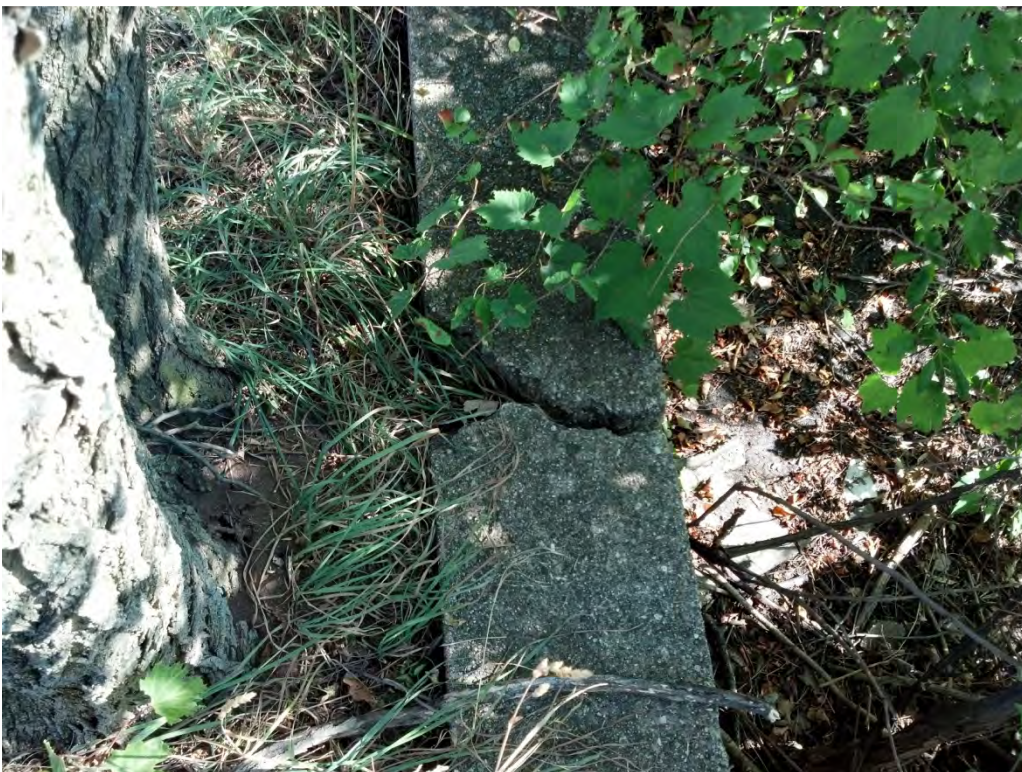
Severe vertical crack and spall in retaining wall

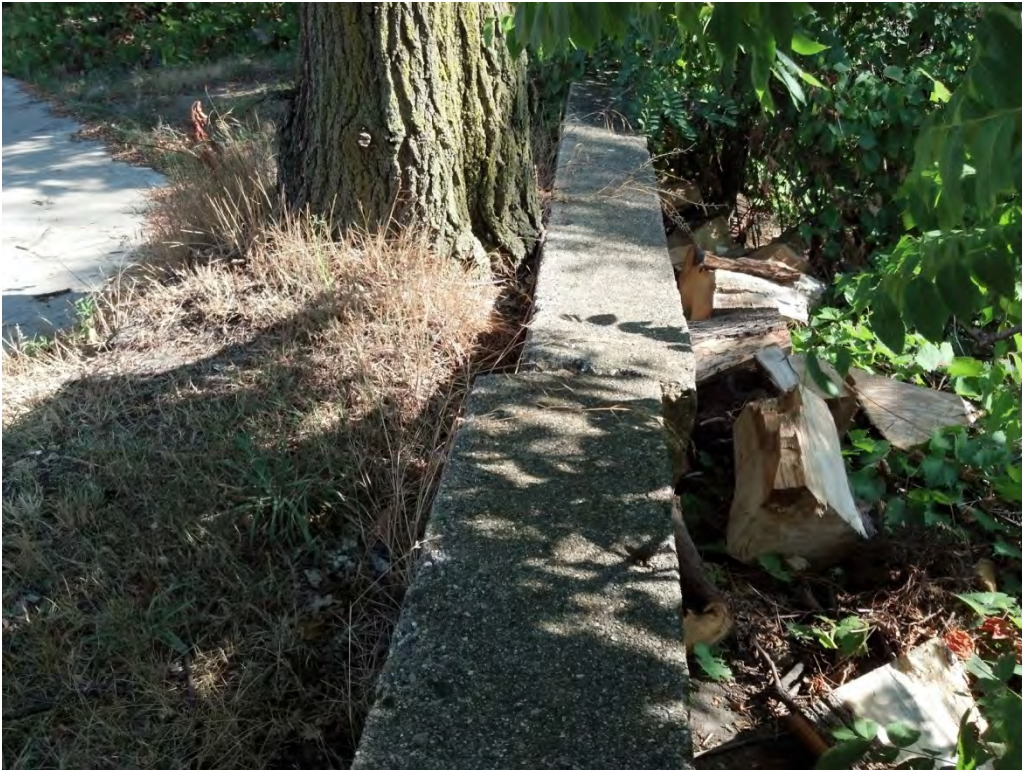
Critical cracking and leaning of wall at tree growth

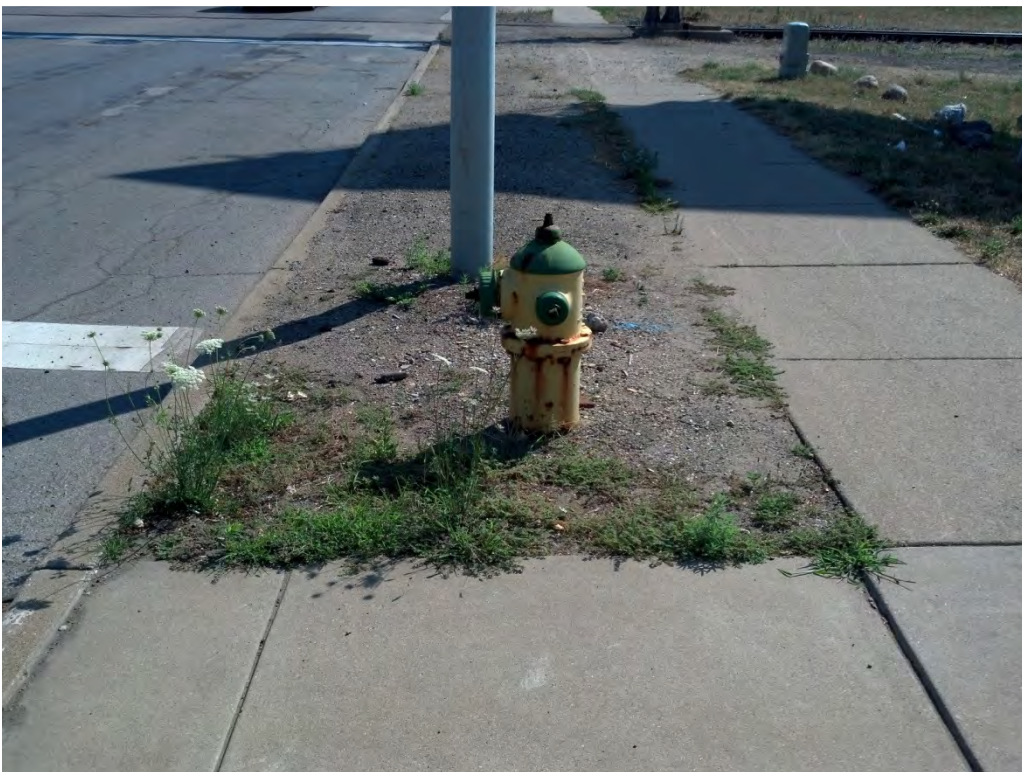
- The fire hydrant is in fair condition, with paint flaking and minor surface corrosion.

View of box looking east showing corrosion

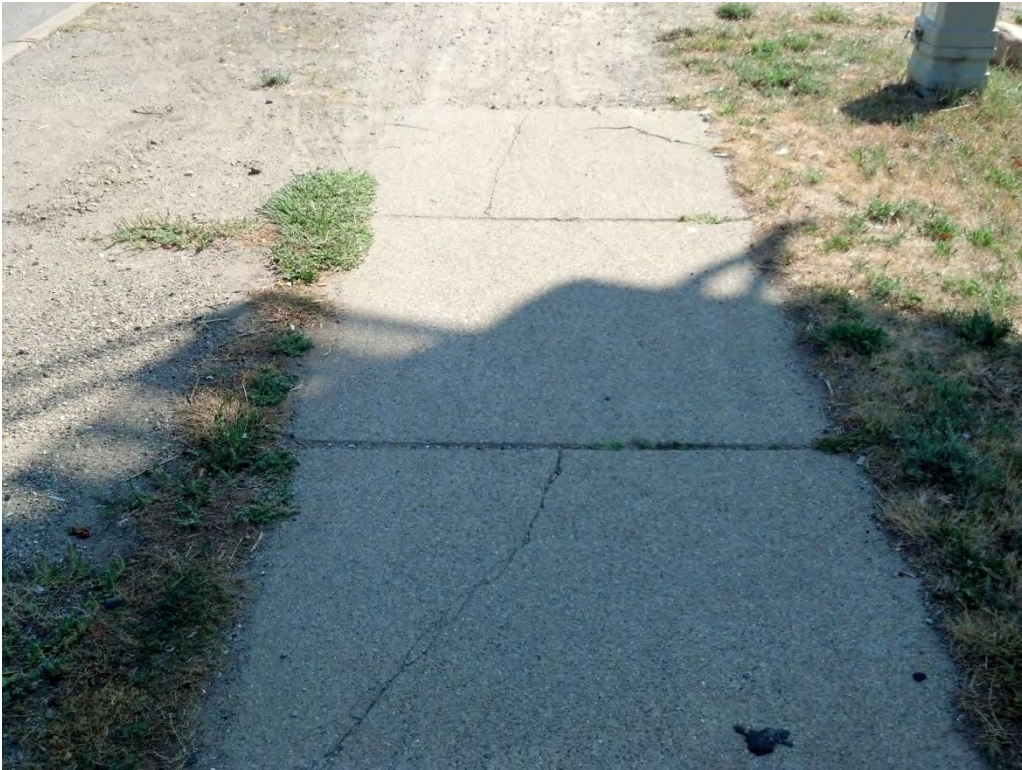
- The east flag and 3<sup>rd</sup> from east flag of concrete have moderate cracking.

Cracking in the east flag and 3<sup>rd</sup> from east

- The existing sidewalk is likely not intended for trucking loads and will likely crack and spall during the work. Damaged sections should be removed and replaced in kind.

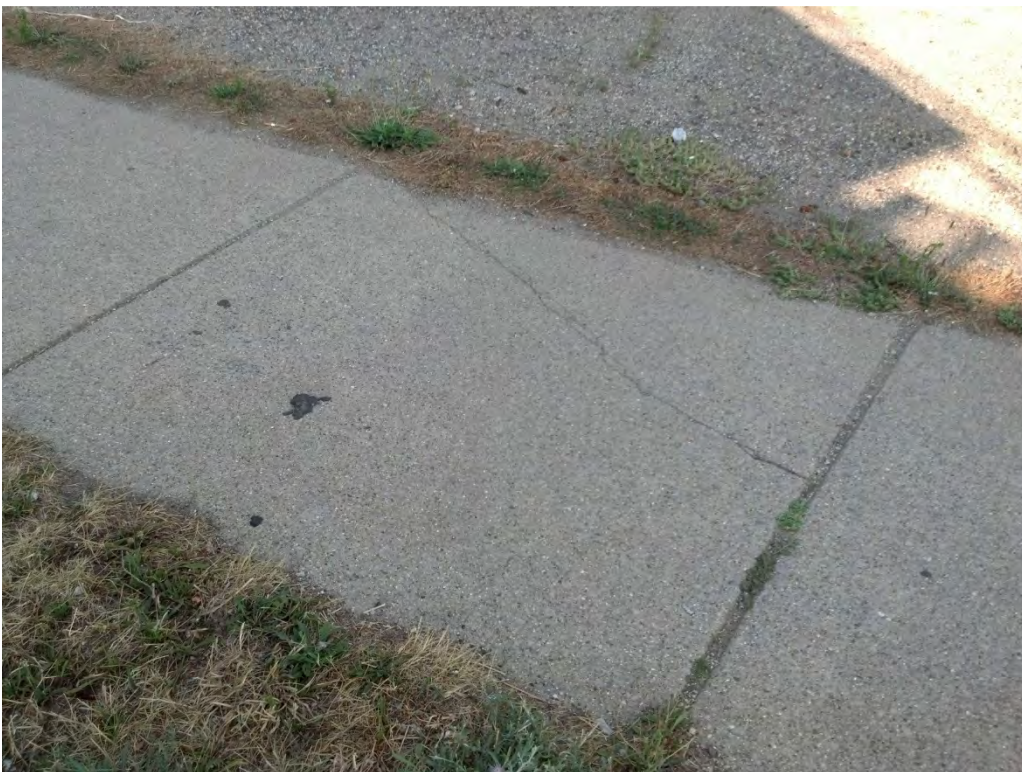
Cracking in the 3<sup>rd</sup> flag of sidewalk from the east

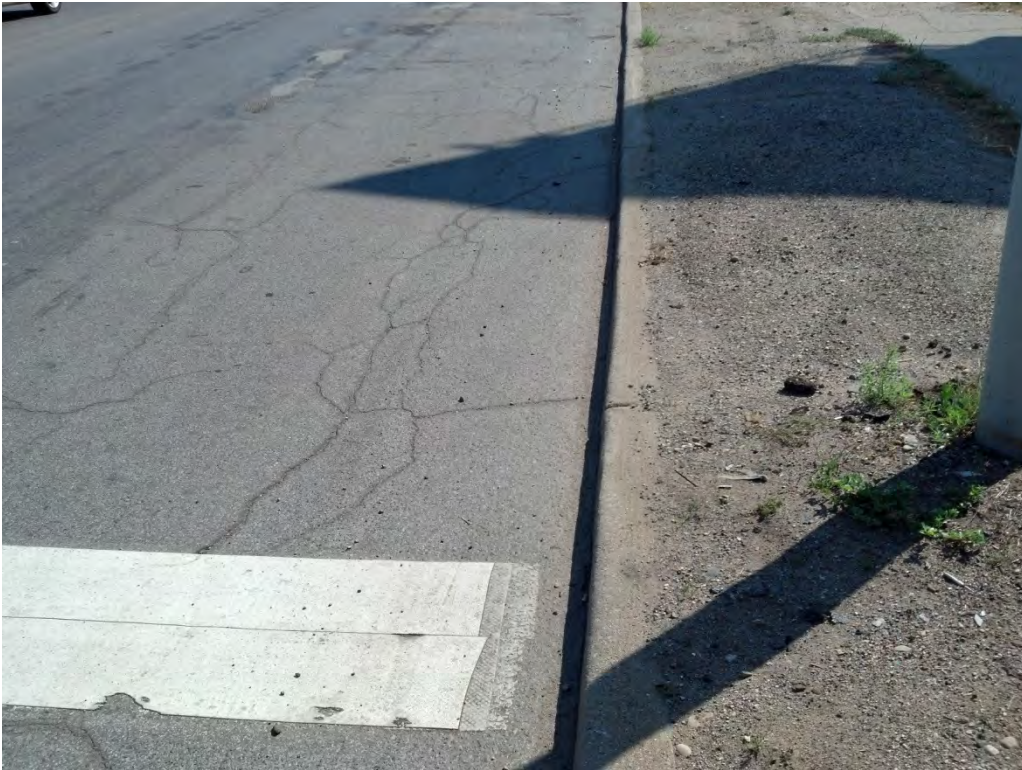
- Asphalt pavement has been treated with chip seal. Severe cracking was noted in the pavement.
- The curb pan has been overlaid during subsequent paving operations.
- Scattered cracking and spalling was noted near the railroad stop bar.

Alligator cracking in asphalt pavement

- Repair asphalt pavement and/or concrete curb and gutter if damaged during the work.

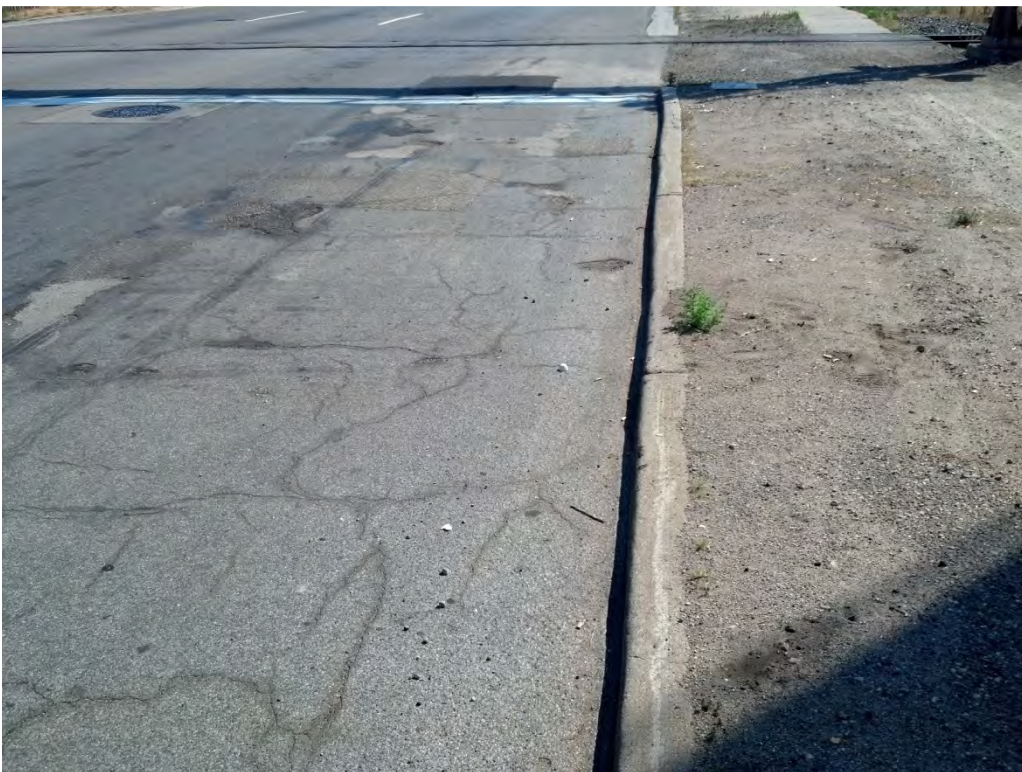
Block cracking and cold patch in asphalt pavement

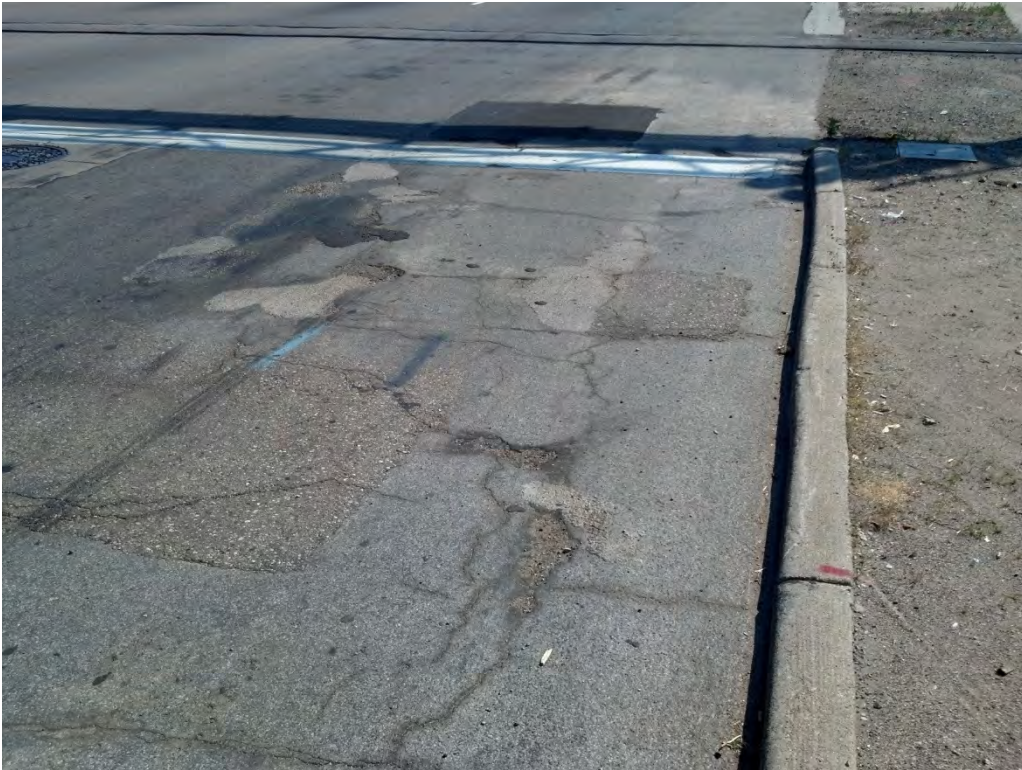
Block cracking and cold patch in asphalt pavement

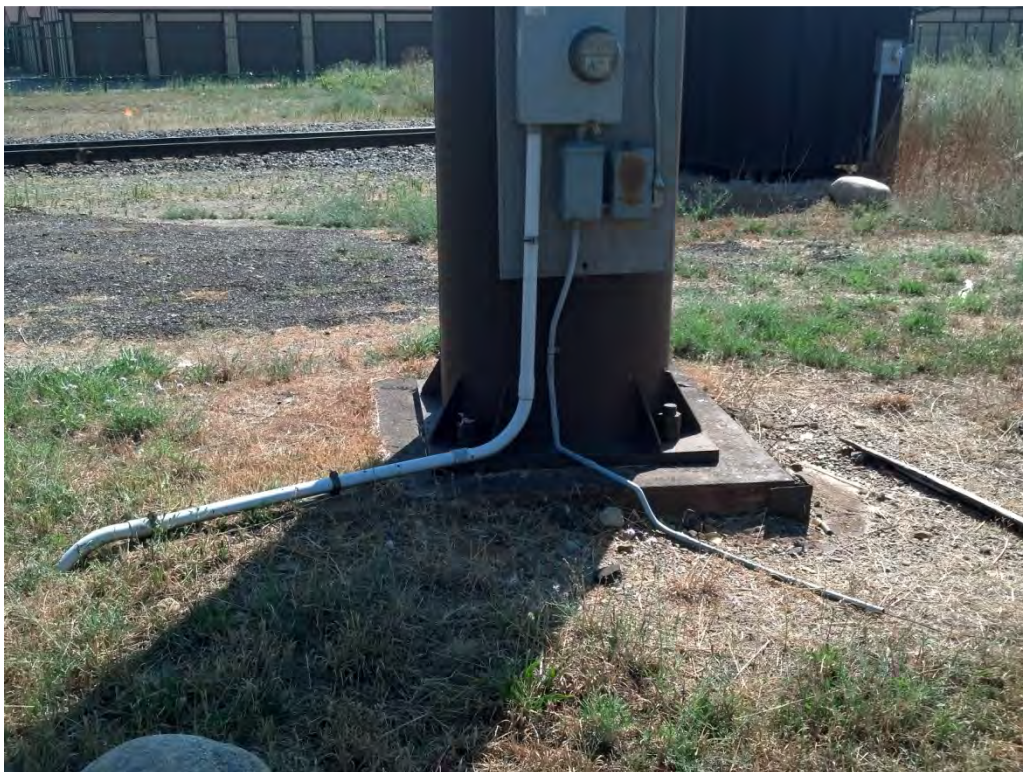
- The steel column has minor scrapes and flaking paint.
- There is an electric service panel on the west side mounted on a timber panel. One of the box covers is loose.
- The electric conduit extending to the southwest is loose.
- The grounding rod is exposed and loose.
- The exposed concrete pedestal has hairline cracking and isolated spalling.

Conduit and service panel on west side of billboard

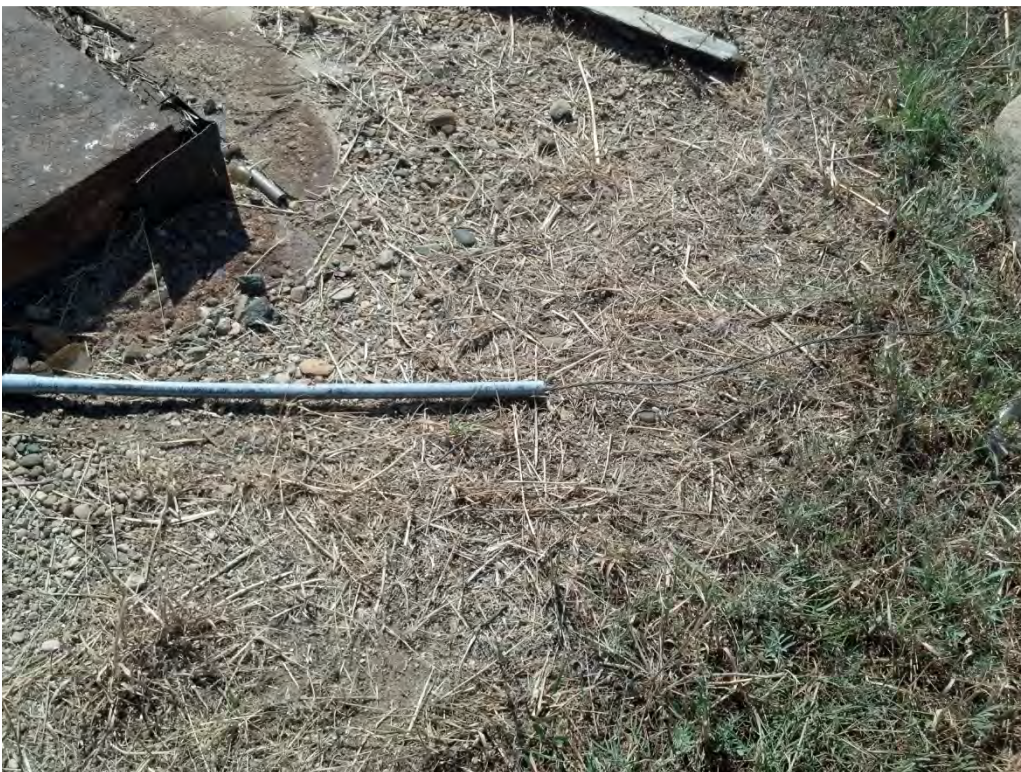
Loose conduit and exposed wire extending to the southwest

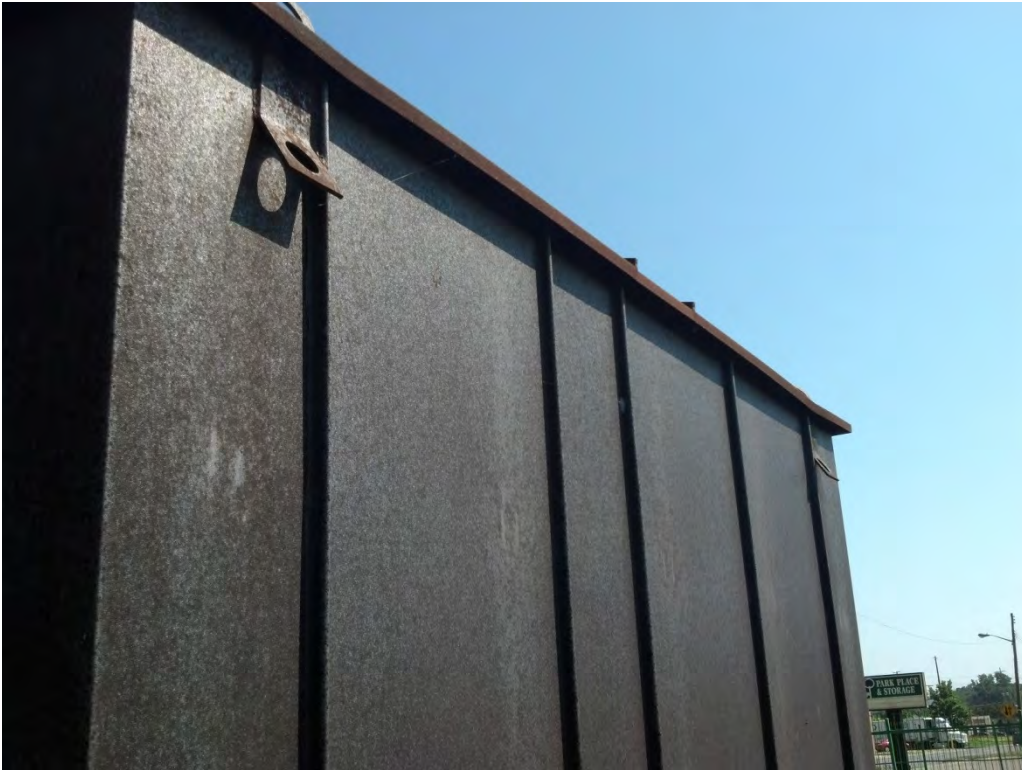
- The siding has moderate to severe surface corrosion.
- There is a sink hole under the northwest corner.
- There is an electric service panel on the west wall.

Surface corrosion on side of shed

- The shed structure should be identified/protected with construction fencing or similar during the work.
